THE NEW PAKYONG AIRPORT (SIKKIM, INDIA)

An impressive application of Maccaferri solutions

MACCAFERRI

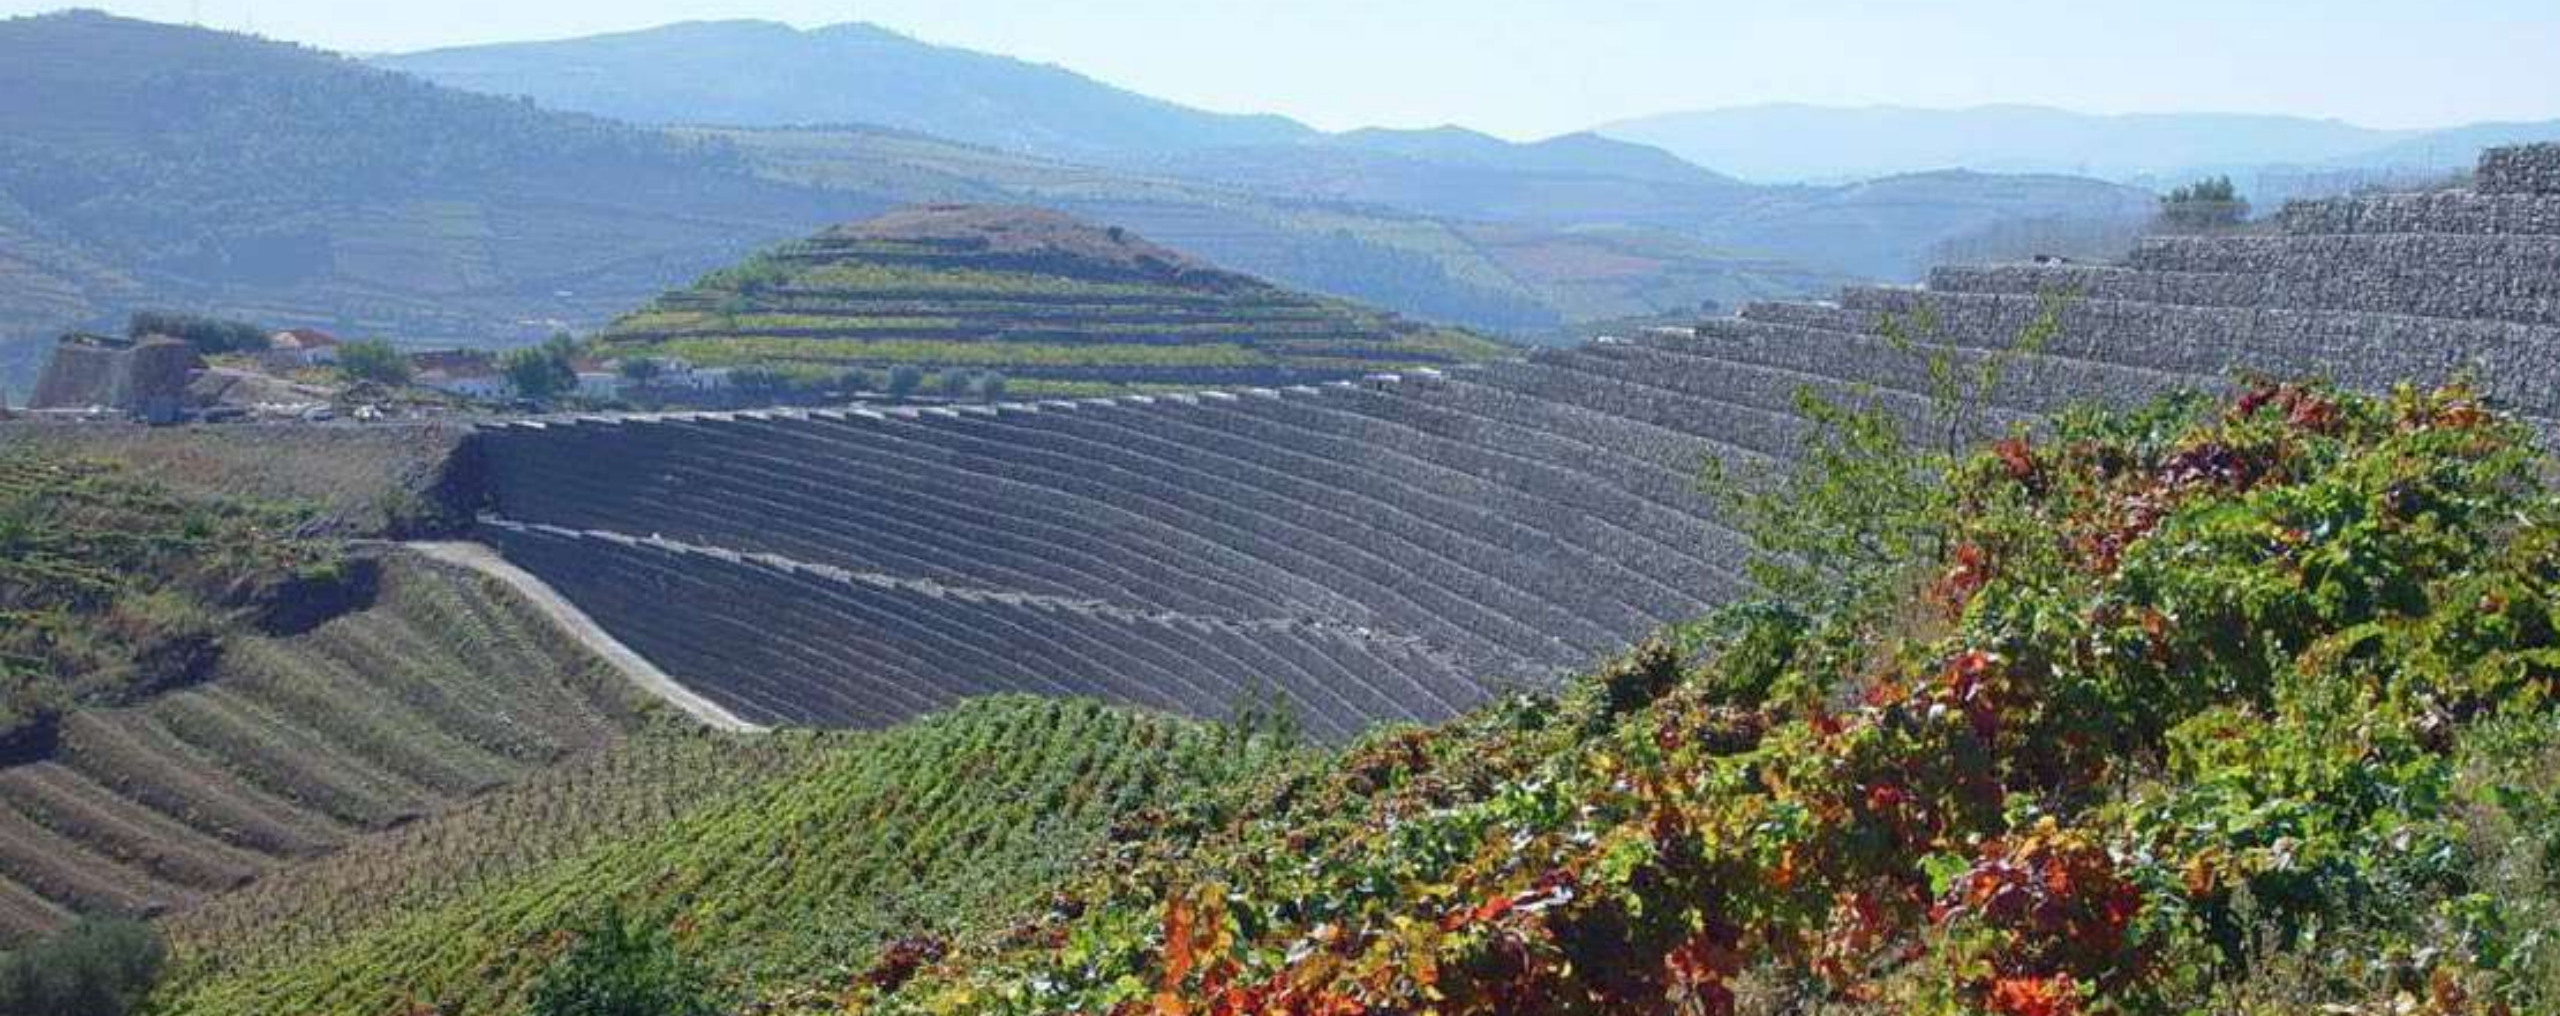
AUDIT ON 29 m WALL (PORTUGAL)

29 m high wall built in 2001

Both Terramesh System and Green Terramesh were used

Geogrid reinforcement lengths up to 15 m

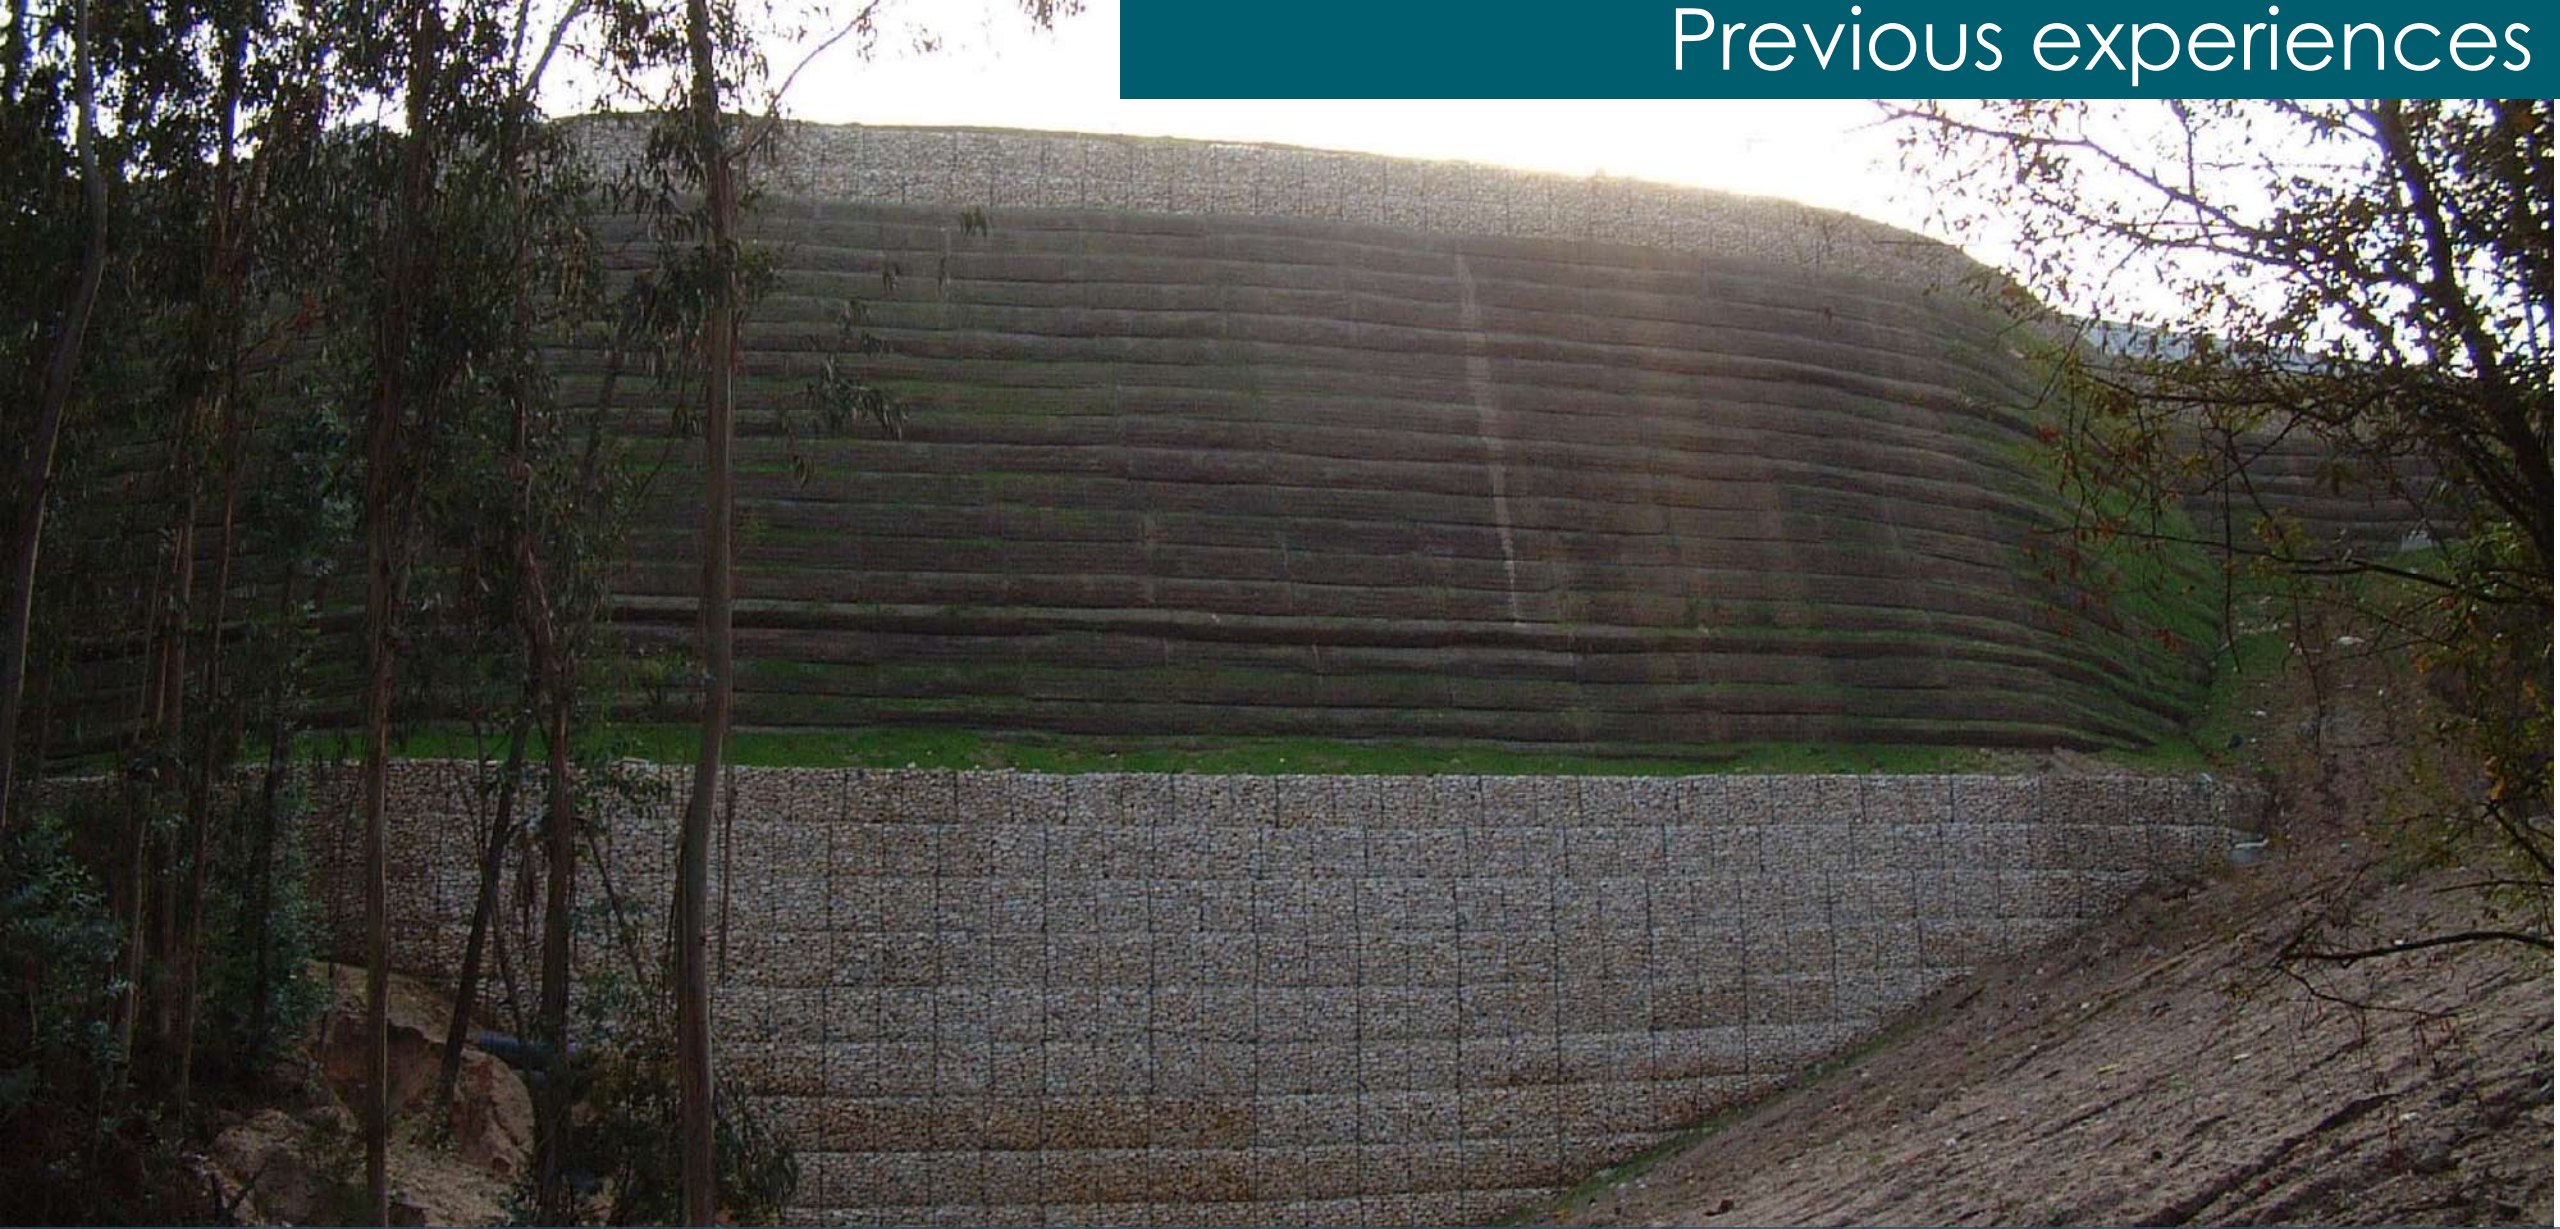
Leiria, Portugal

The Leiria wall in 2009 (8 years after construction)

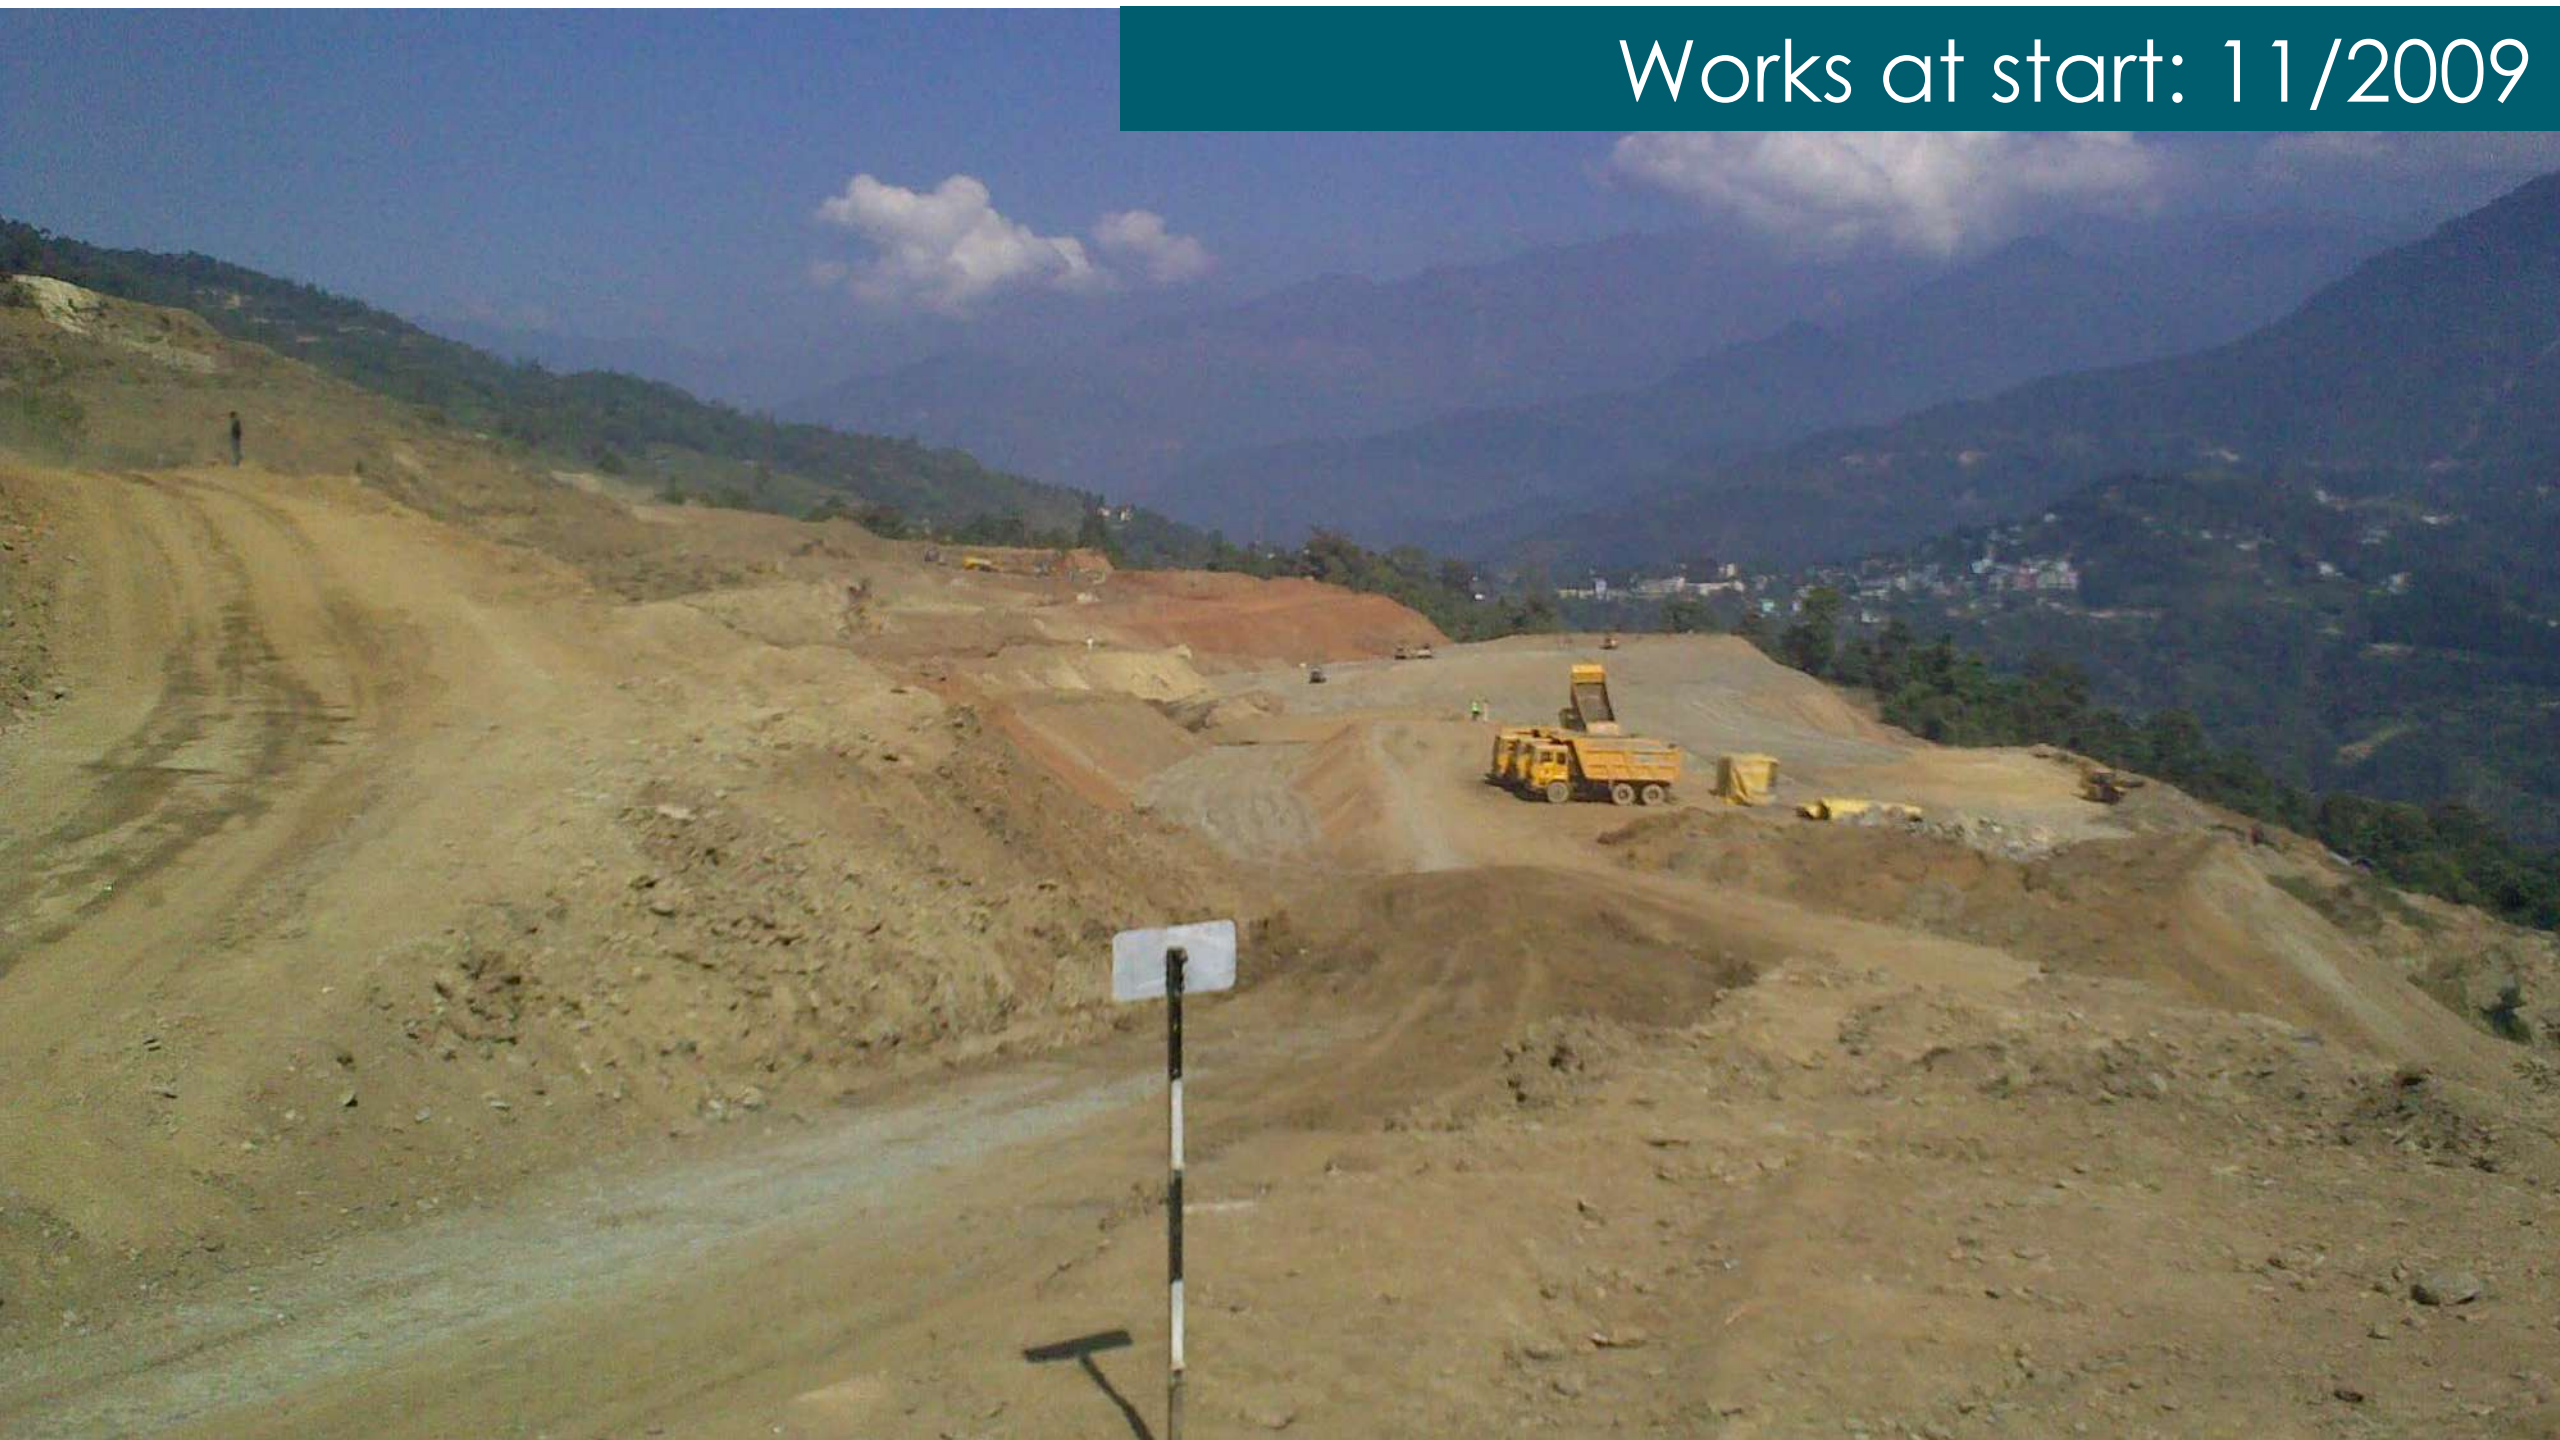
May 2010

Works at start: 11/2009

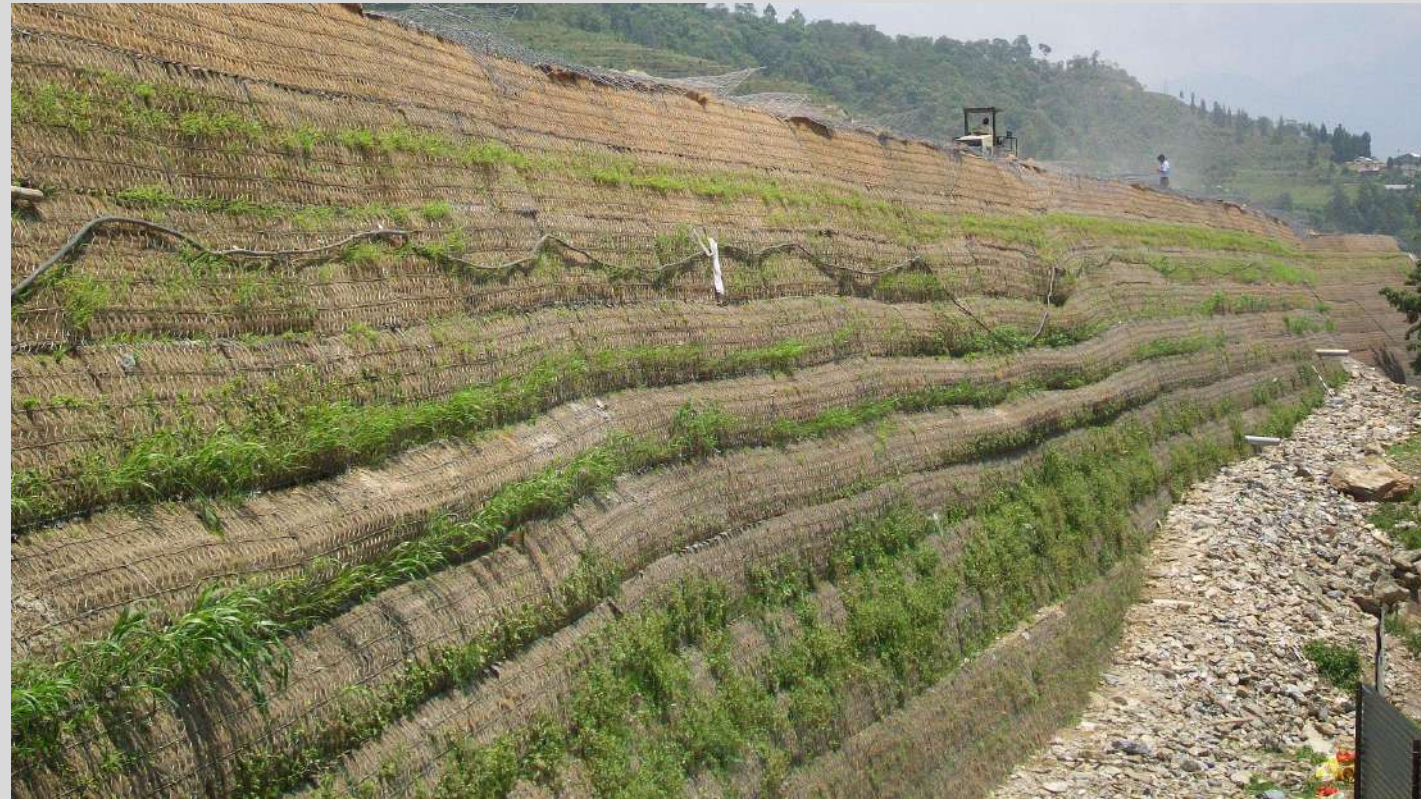
- **Incorrect compaction of the structural fill**
- Incorrect installation of the gabion stones
- Scour protection of the culvert outlets

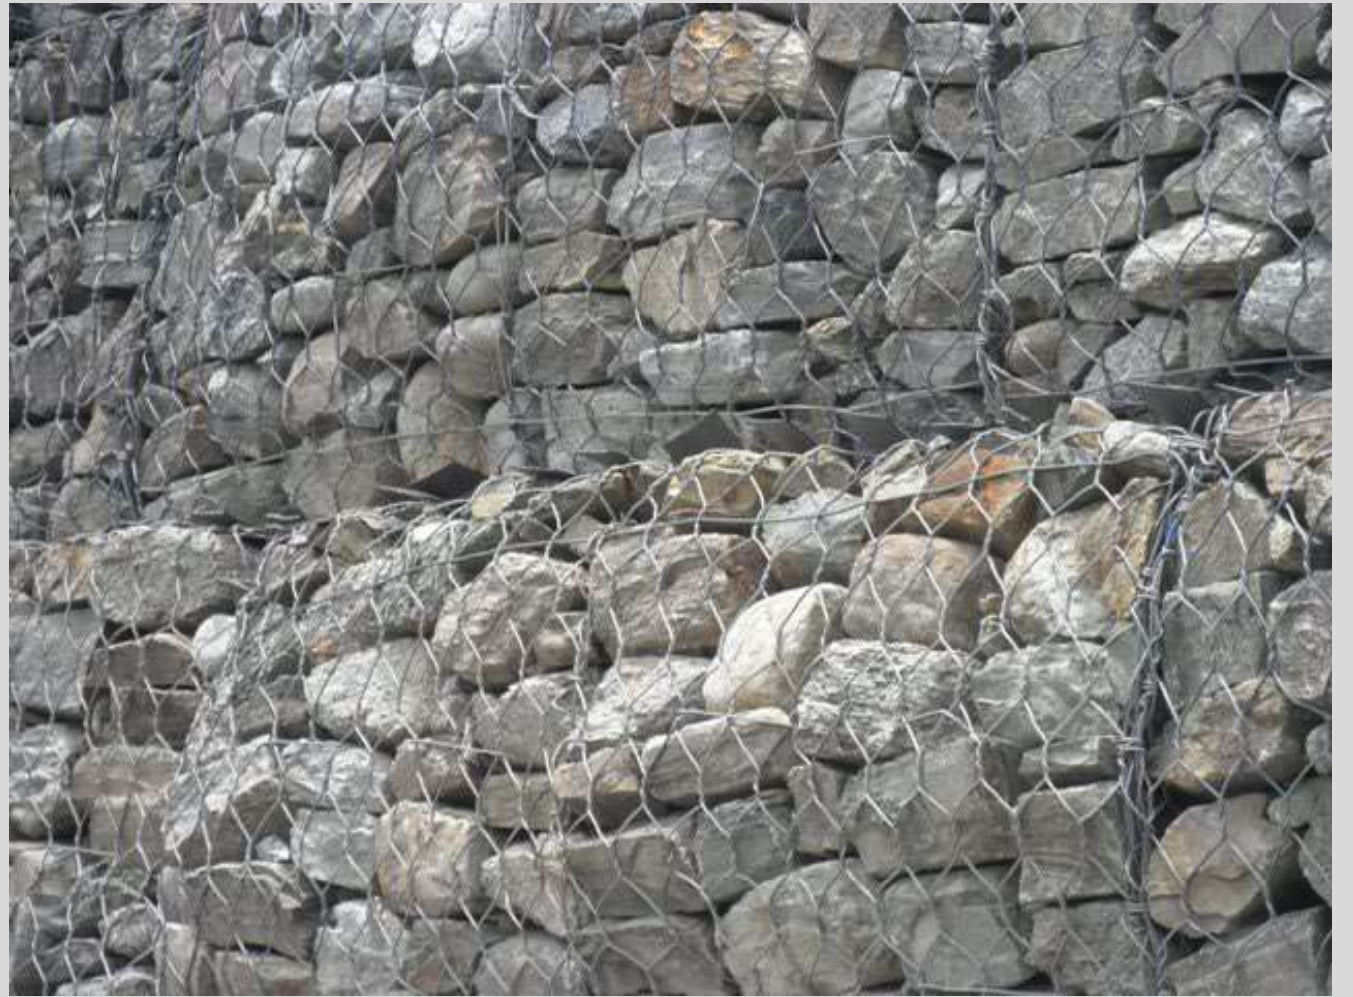
- Incorrect compaction of the structural fill
- **Incorrect installation of the gabion stones**
- Scour protection of the culvert outlets

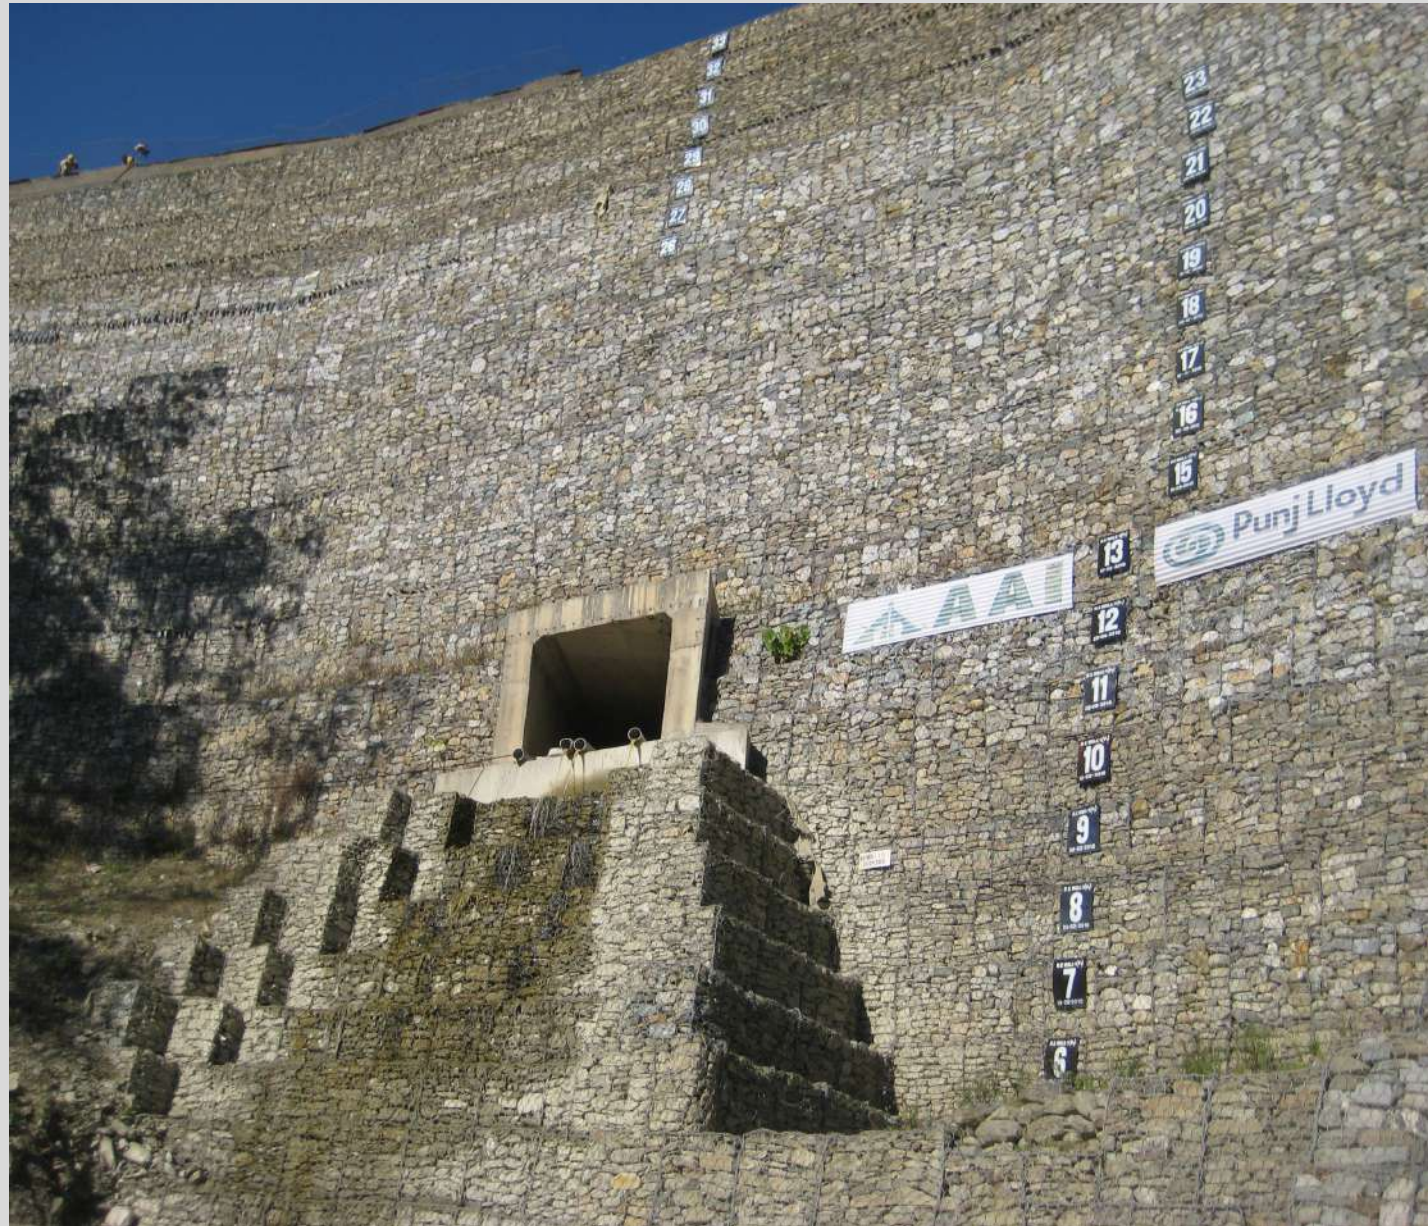
- Incorrect compaction of the structural fill
- Incorrect installation of the gabion stones
- **Scour protection of the culvert outlets**

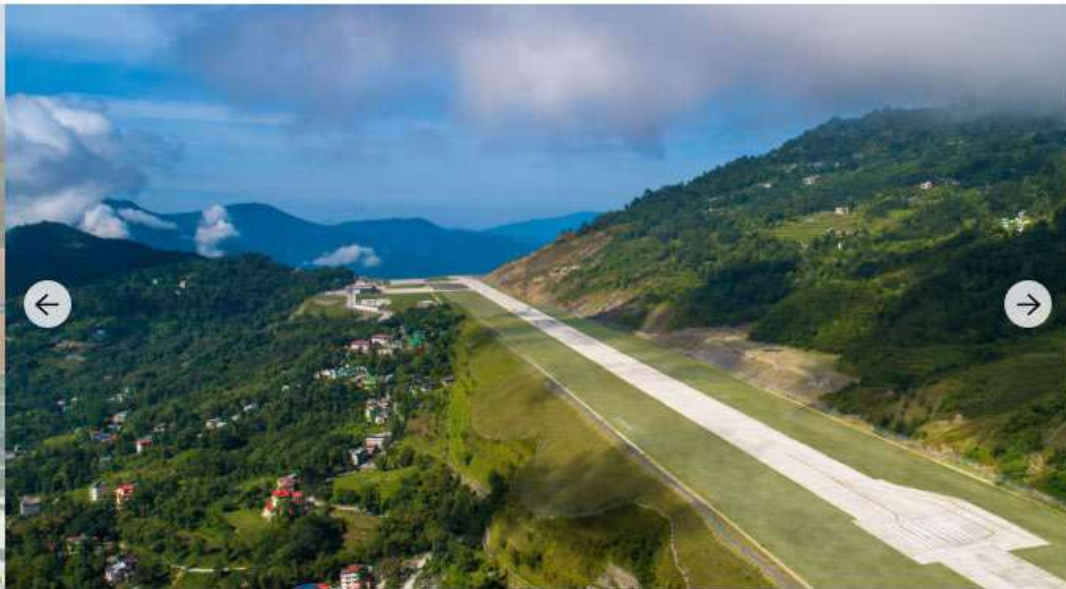
ParaMesh construction, cutting & filling slope and drainage activities are finished.

ParaMesh structures successfully withstood the catastrophic seismic event that happened in Sikkim in September 2011 (Magnitude 6.9), right after the monsoon period which enhances the criticality further.

While most of the other infrastructure failed in Sikkim, ParaMesh structures performed excellent owing to their flexible nature, though the seismic event happened ($kh > 0.3$) was higher than the magnitude for which these structures were designed ($kh = 0.12$).
